HIGGINBOTHAM SCHOOL WINDOW ASSESSMENT

SUMMARY

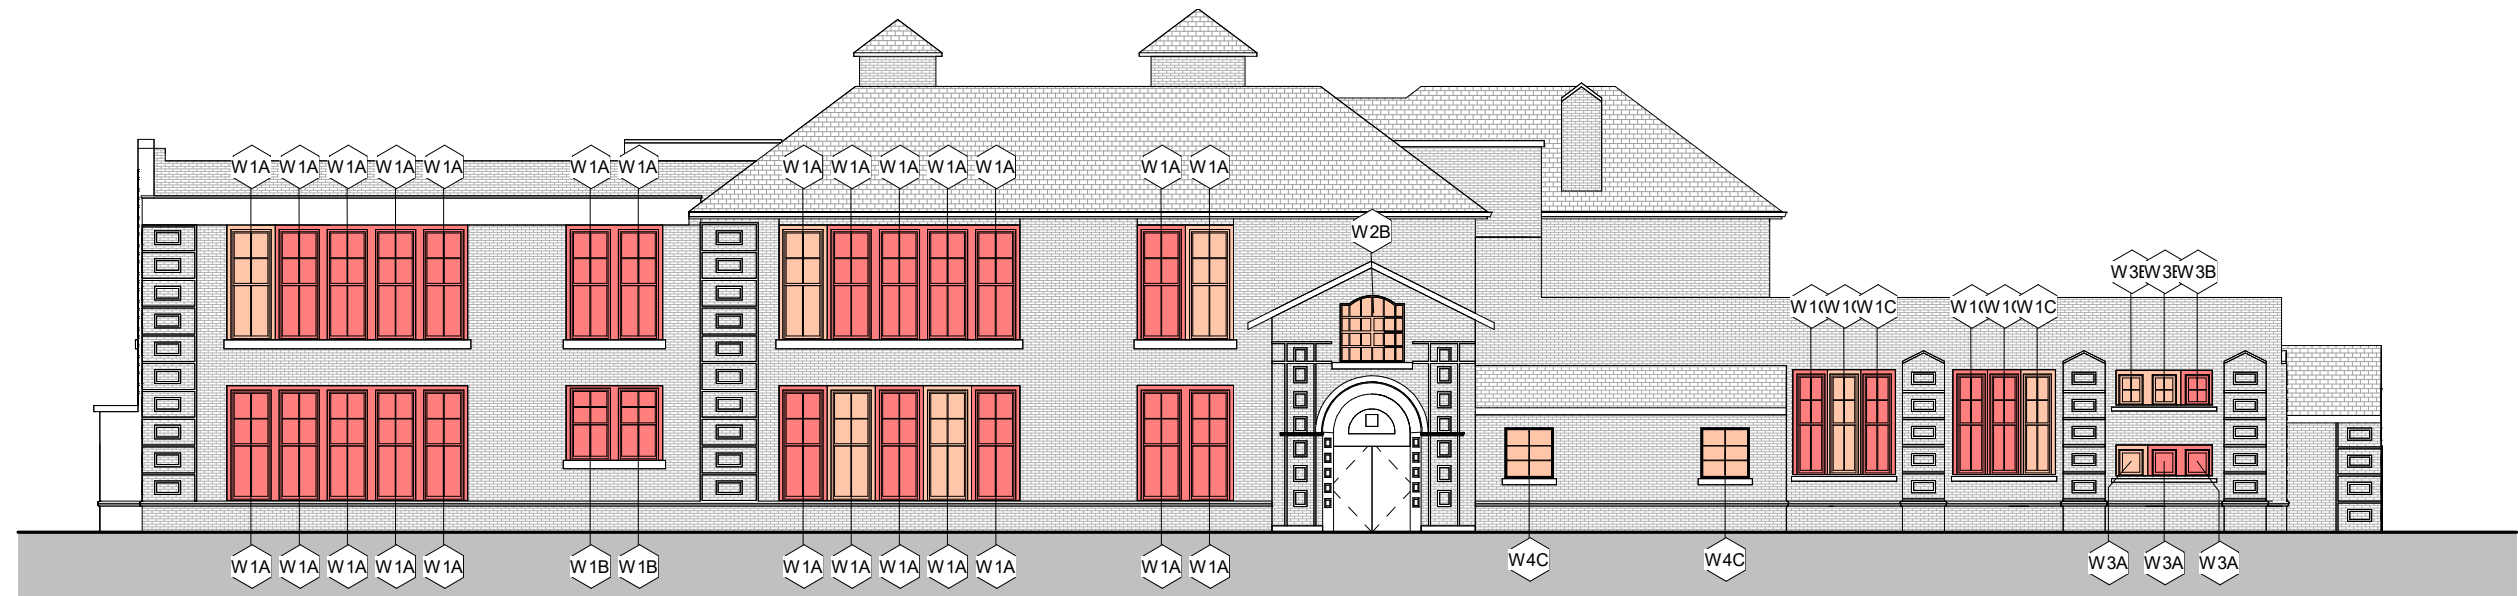
WEST ELEVATION

WINDOW CONDITION

- MAJOR REPAIRS NEEDED
- REPLACEMENT NEEDED

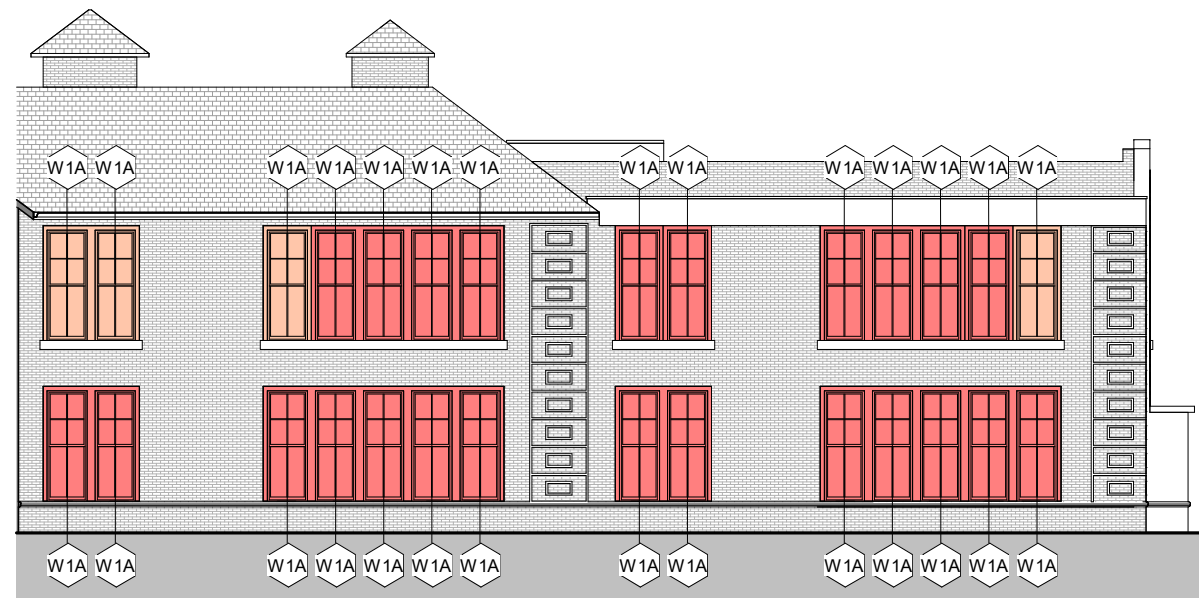
COURTYARD EAST ELEVATION

WINDOW CONDITION

- MAJOR REPAIRS NEEDED
- REPLACEMENT NEEDED
