STAFF REPORT 01-22-2020 REGULAR MEETING
APPLICATION NUMBER: 20-6602
ADDRESS: 2224 SEMINOLE STREET
HISTORIC DISTRICT: INDIAN VILLAGE
APPLICANT: STEVEN FLUM, ARCHITECT
PROPERTY OWNER: BENSON BRADY
DATE OF COMPLETE APPLICATION: 01-02-2020
STAFF SITE VISIT: 01-07-2020

SCOPE: CONSTRUCTION OF THREE (3) NEW ADDITIONS TO EXISTING GARAGE

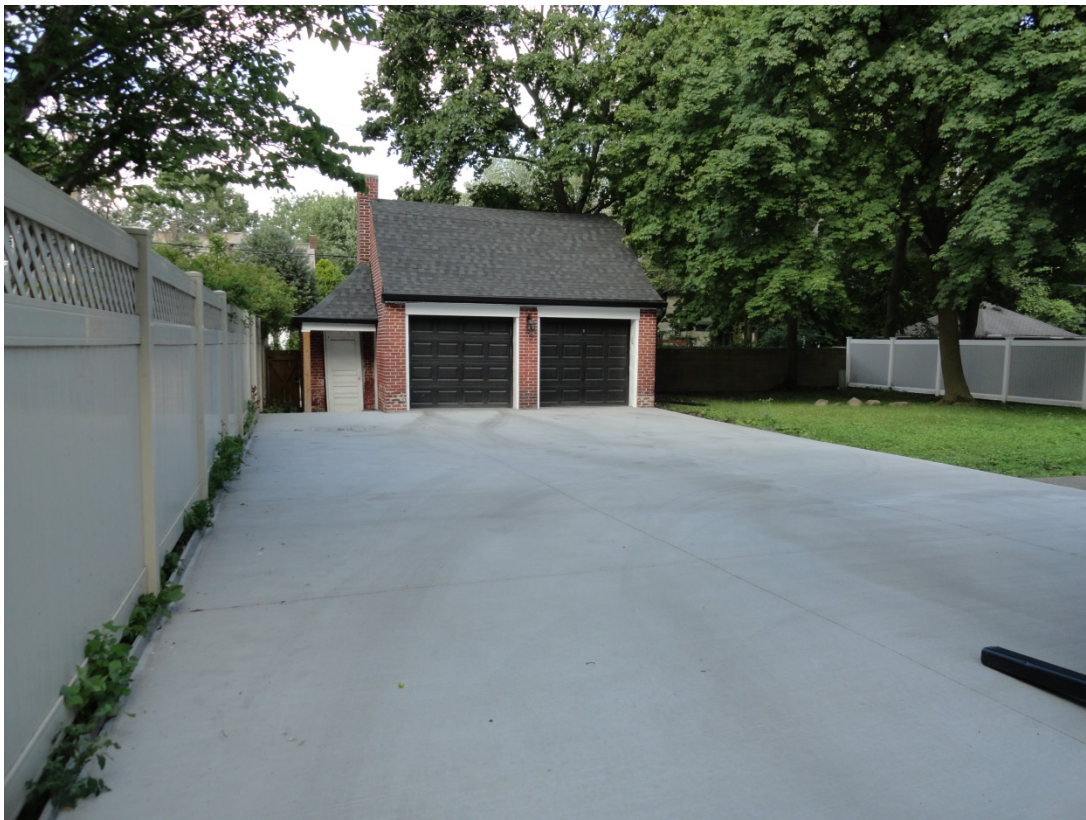
View of existing garage

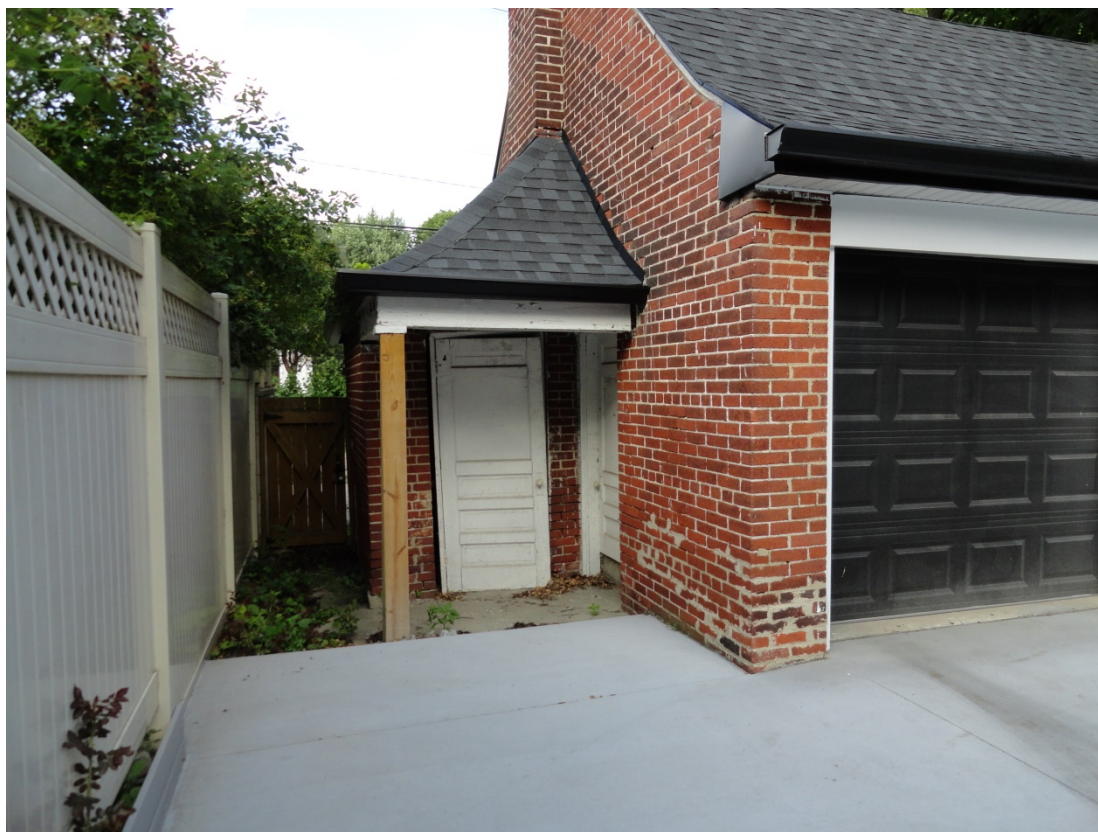
Existing garage and north shed addition

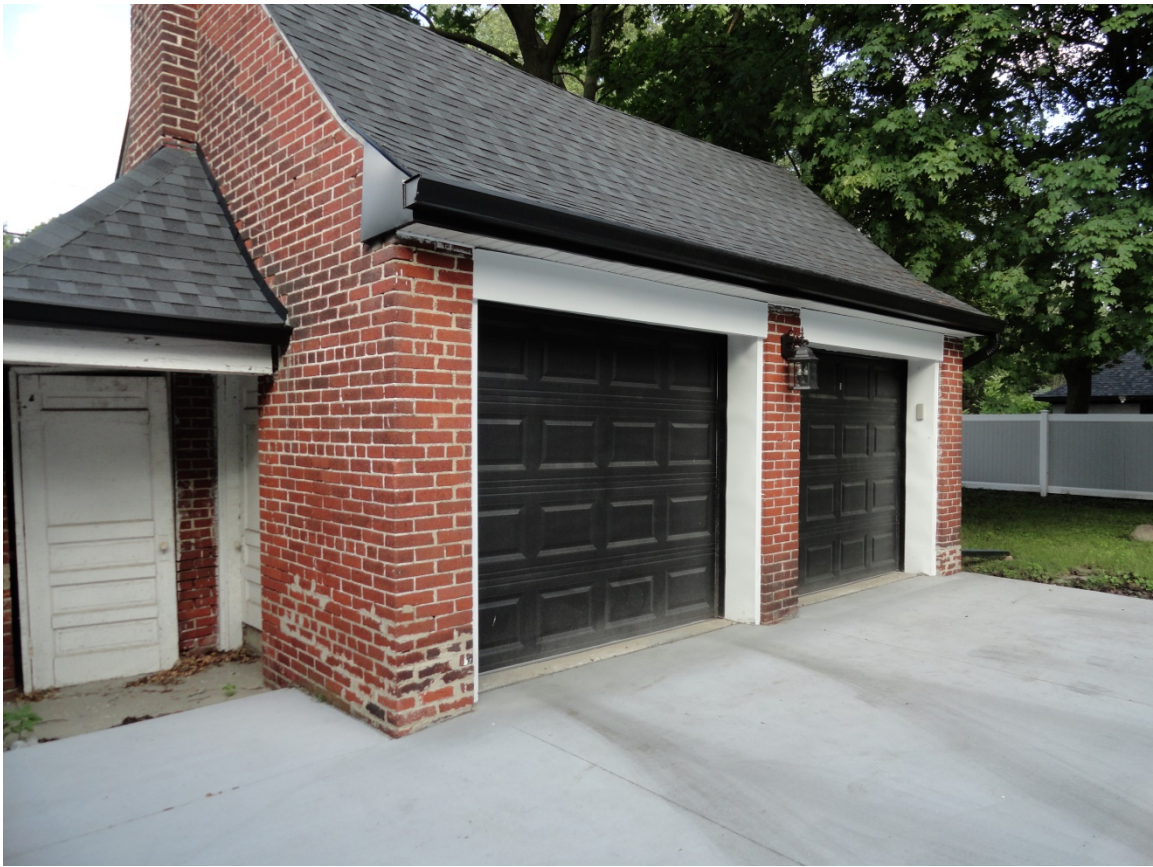
Existing garage west elevation

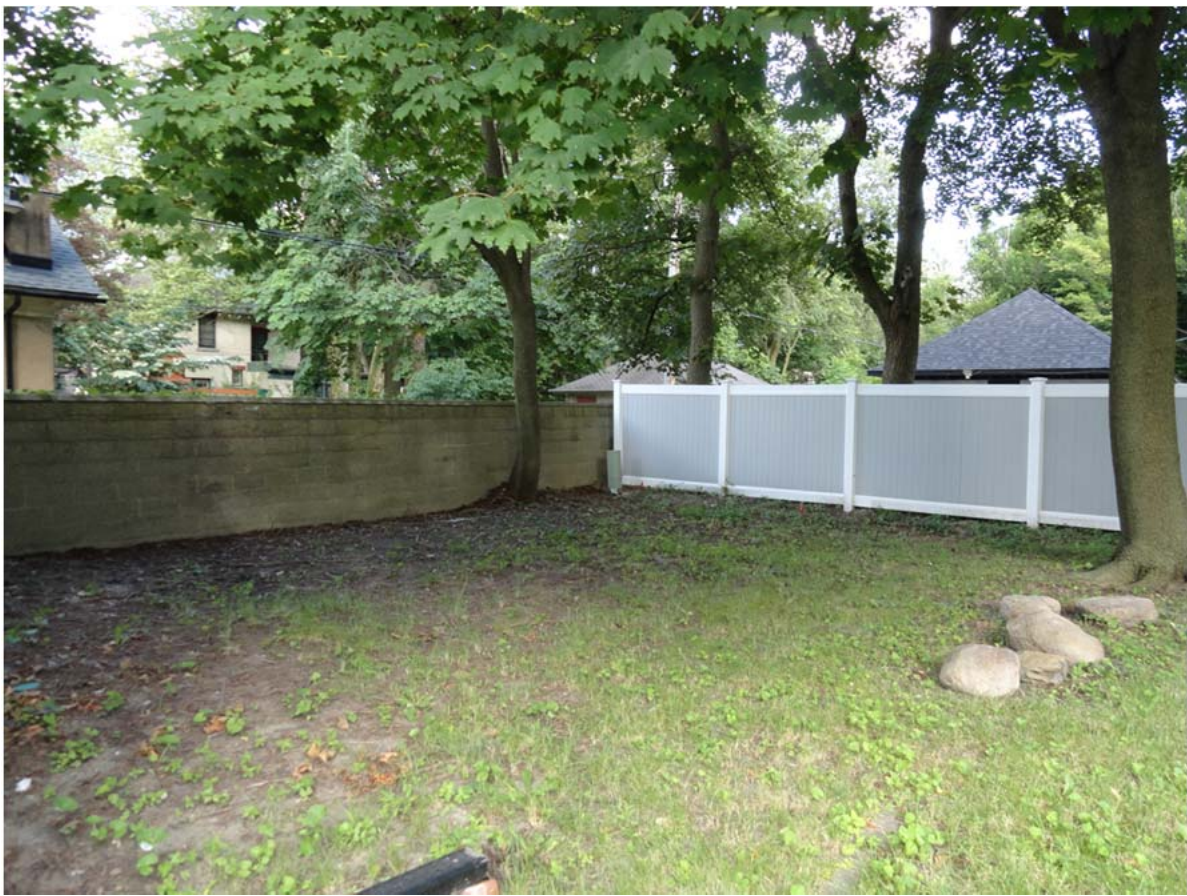
Rear yard next to existing garage

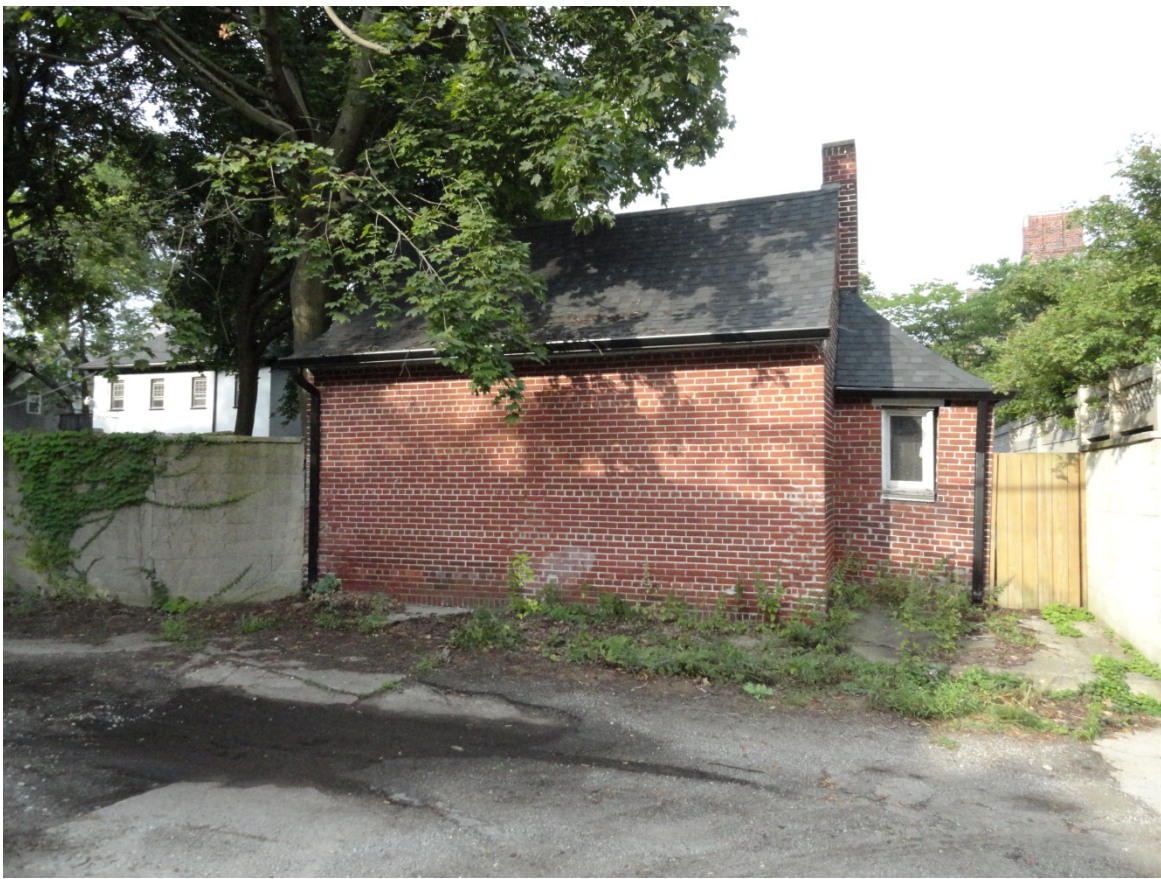
Rear of existing garage at alley

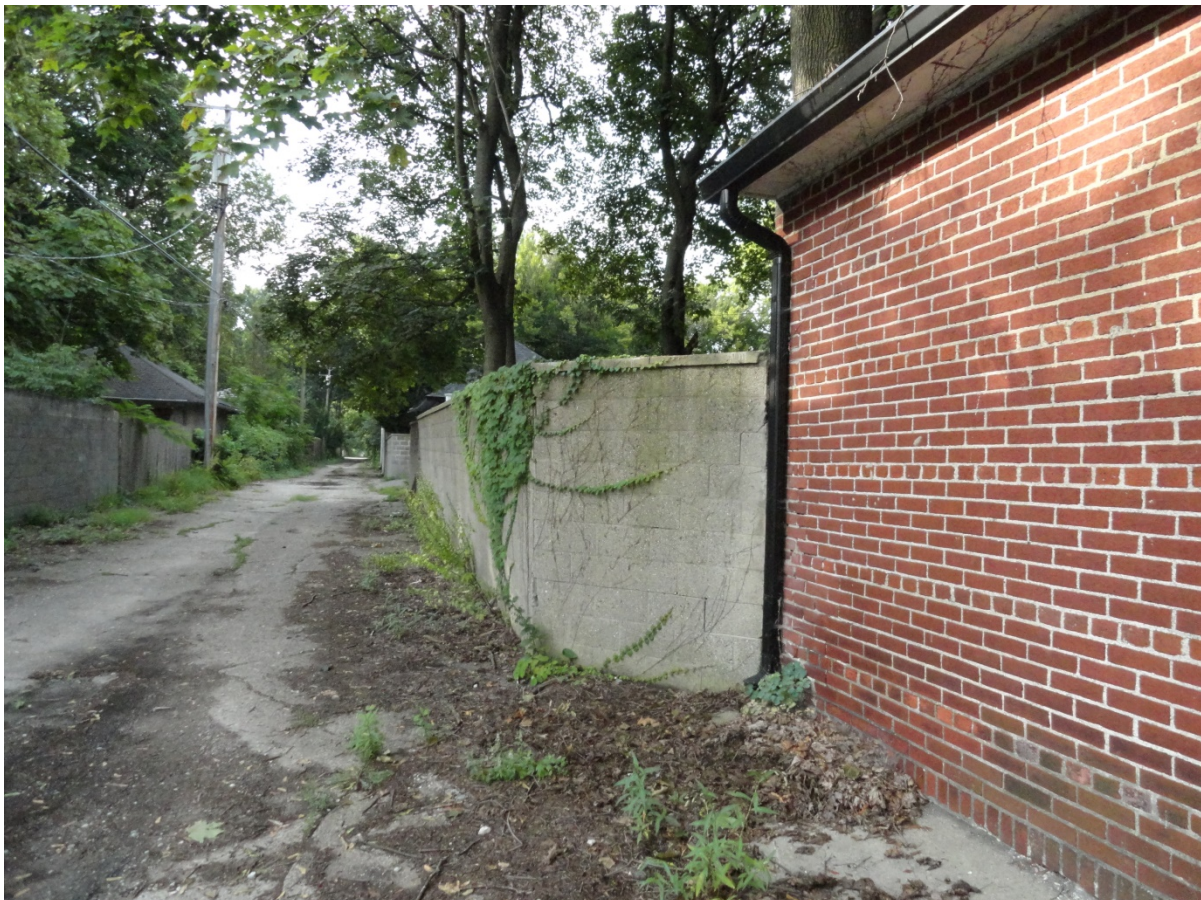
Rear of existing garage and masonry wall at alley

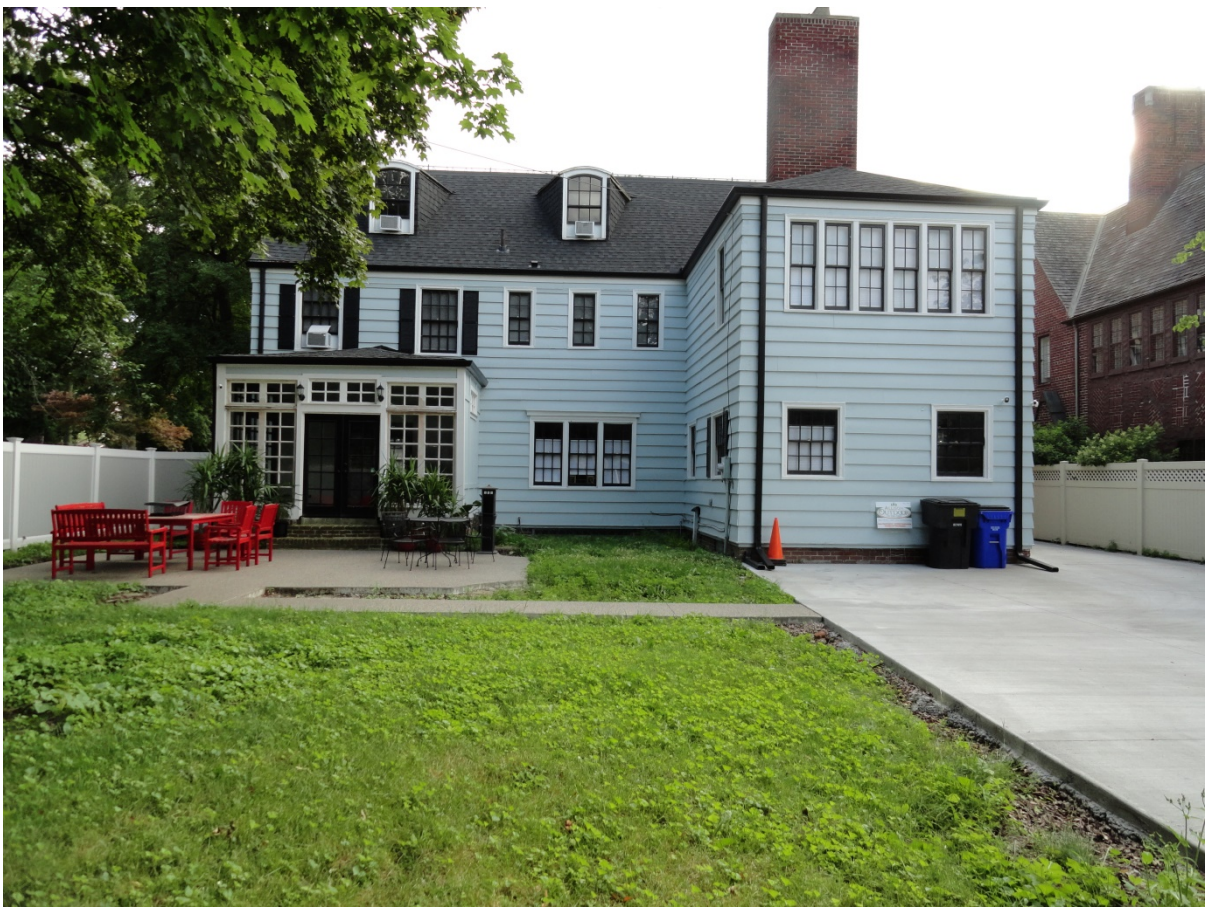
Rear elevation of house, existing patio and lawn area

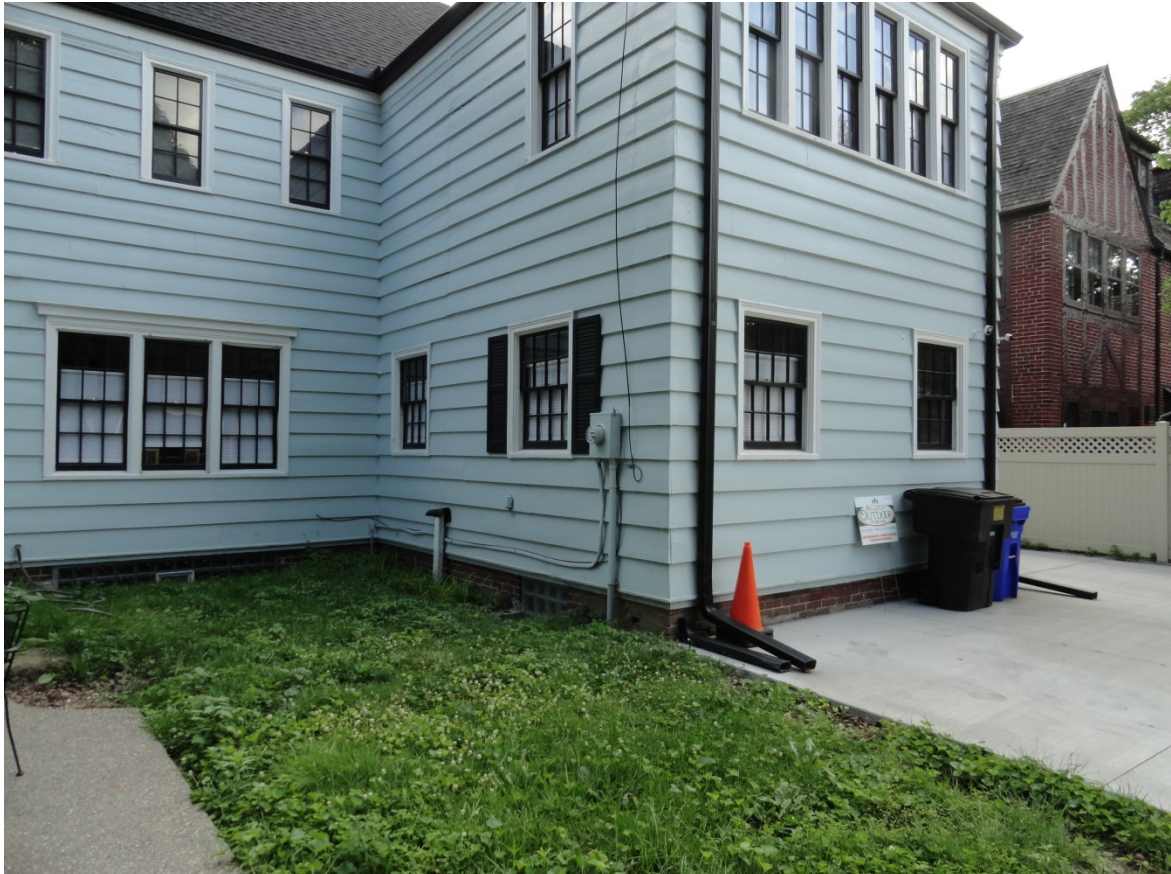
Rear elevation of house and utilities
2224 Seminole

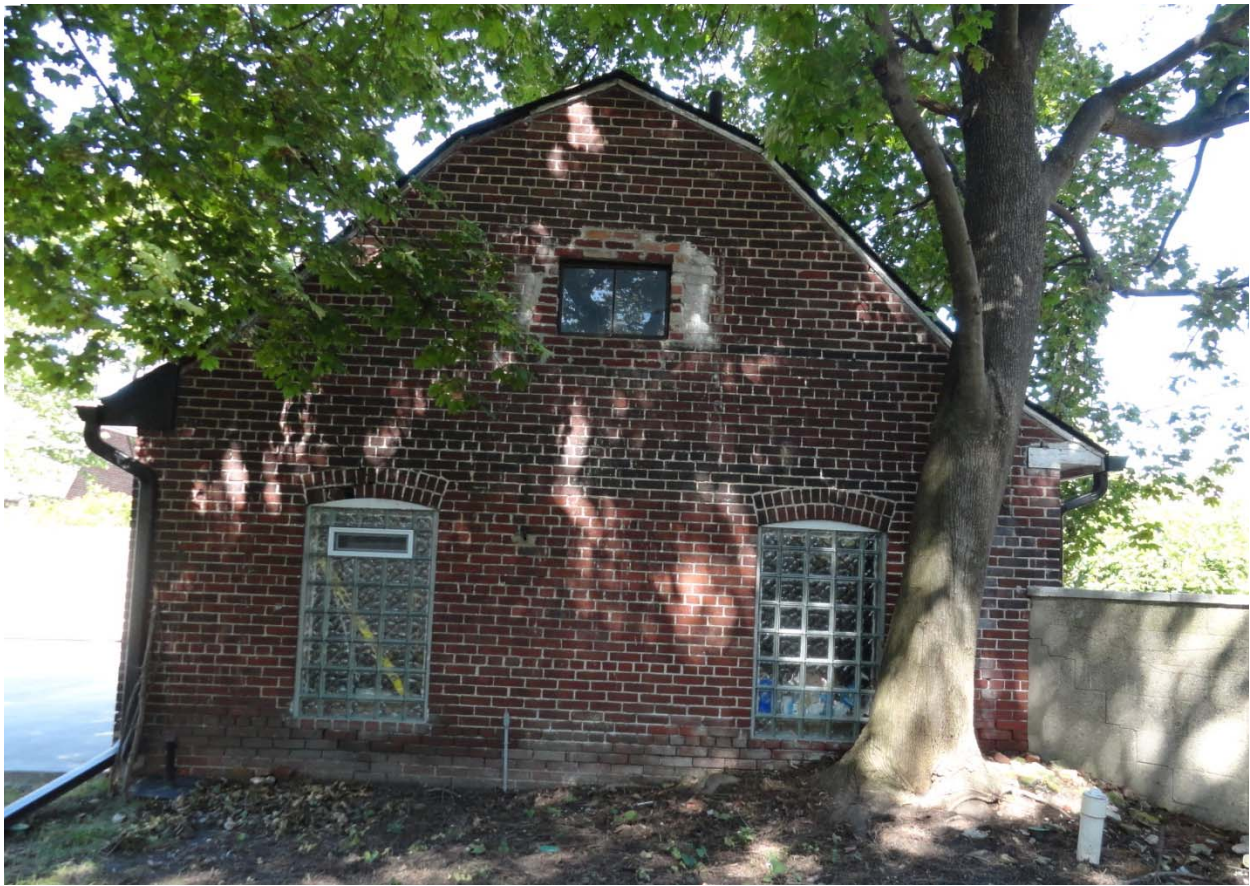
2-East Elevation at alley
2224 Seminole

- Good Condition. There are newer asphalt roof, metal flashing, gutters and downspouts (Pictures #1, #2)

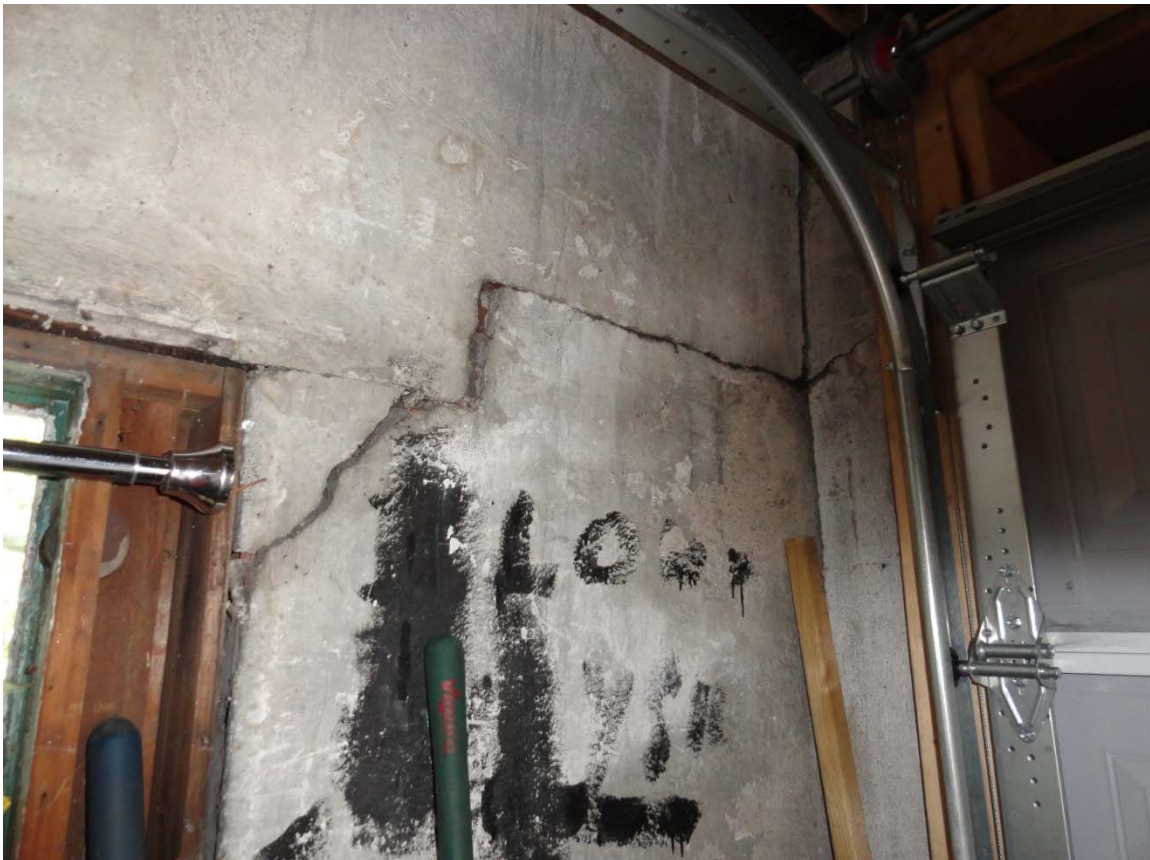
9-Southwest corner masonry issue

- Poor Condition. The shed foundation and walls showing signs of imminent failure (Pictures #4, #5, #15-#19).
- Poor Condition. The southwest corner of the garage exterior brick wall is cracking. The cracking is telegraphing the entire width of the wall. Evidence of this is shown on the interior plaster wall which has the same wall cracking location and pattern (Pictures #9 and #10). It is unclear if this damage was caused by water infiltration or the foundation failing at the southeast corner of the garage.
- Poor Condition. The CMU screen wall is also showing signs of imminent failure (Pictures #20 and #21)

- Poor Condition. The shed show signs of failure with walls cracking and door and window shifting (Pictures #8, #15-#19).
- Poor Condition. The southwest corner of the garage foundation is failing with signs of brick cracking (Pictures #9 and #10).
- Poor Condition. Existing tree is causing damage to the south garage foundation (Pictures #5 and #6)
- Poor Condition. Existing tree is causing damage to the CMU screen wall and is leaning out over the alley right of way (Pictures #20 and #21)

- Fair Condition. The brick masonry has been tuck-pointed in places. Additional tuck-pointing is needed including reconstruction of the shed walls and openings (Pictures #1-#4, #8, #9, #15-#18)

The professional recommendation is to replace the detached garage, alley wall, trees and repair or replace the sanitary line. The estimated cost to replace as-built is \$230,000.

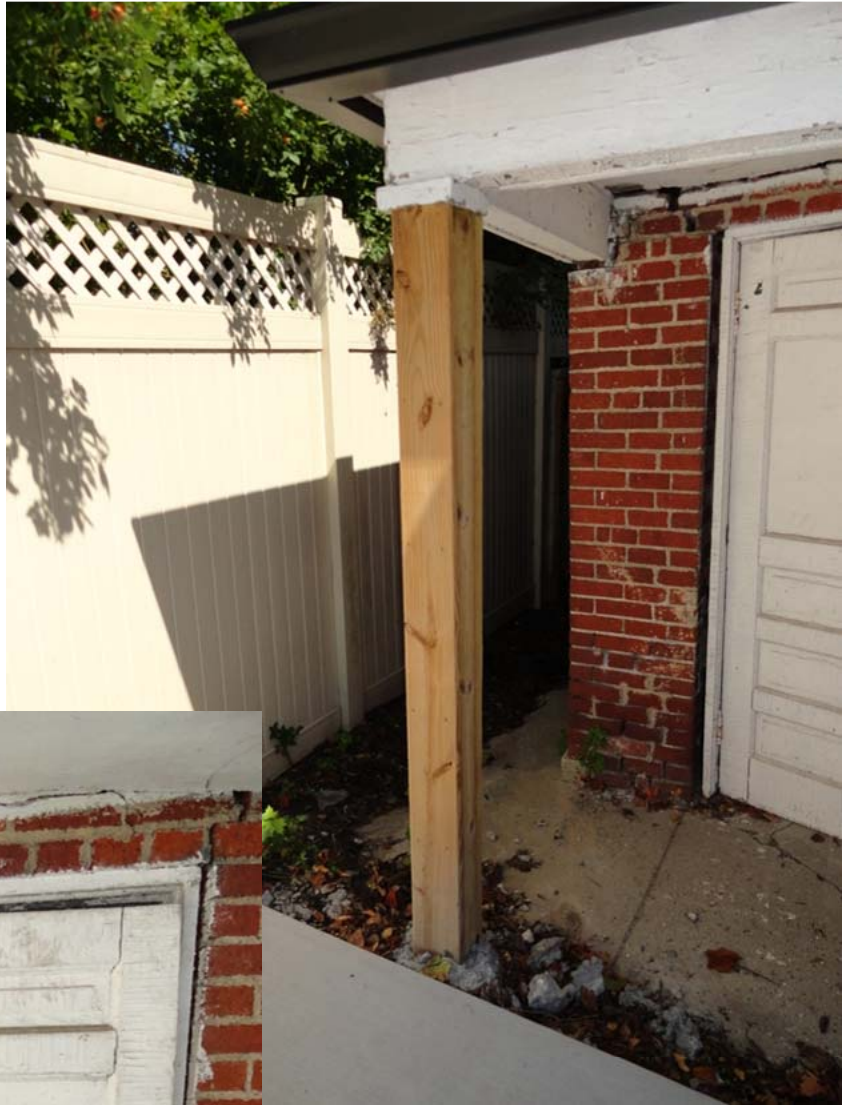
15- Shed Addition
structural issue

- Poor Condition. The shed show signs of the exterior wall shifting and is in need of reconstruction (Picture #8, #15-#19).
- Poor Condition. The CMU alley screen wall leaning towards the alley and is in danger of collapsing. (Pictures #20 and #21).

- Poor Condition. The shed shifting wall and foundations have damaged the window and door openings making them inoperable. (Pictures #4, #5, #15-#19).
