STAFF REPORT: 7/13/2022 REGULAR MEETING

APPLICATION NUMBER: #22-7908

ADDRESS: 1620 ATKINSON

SCOPE: DEMOLISH GARAGE, FENCE, REAR BALCONY AND DECK, (WORK COMPLETED WITHOUT APPROVAL), ERECT NEW GARAGE

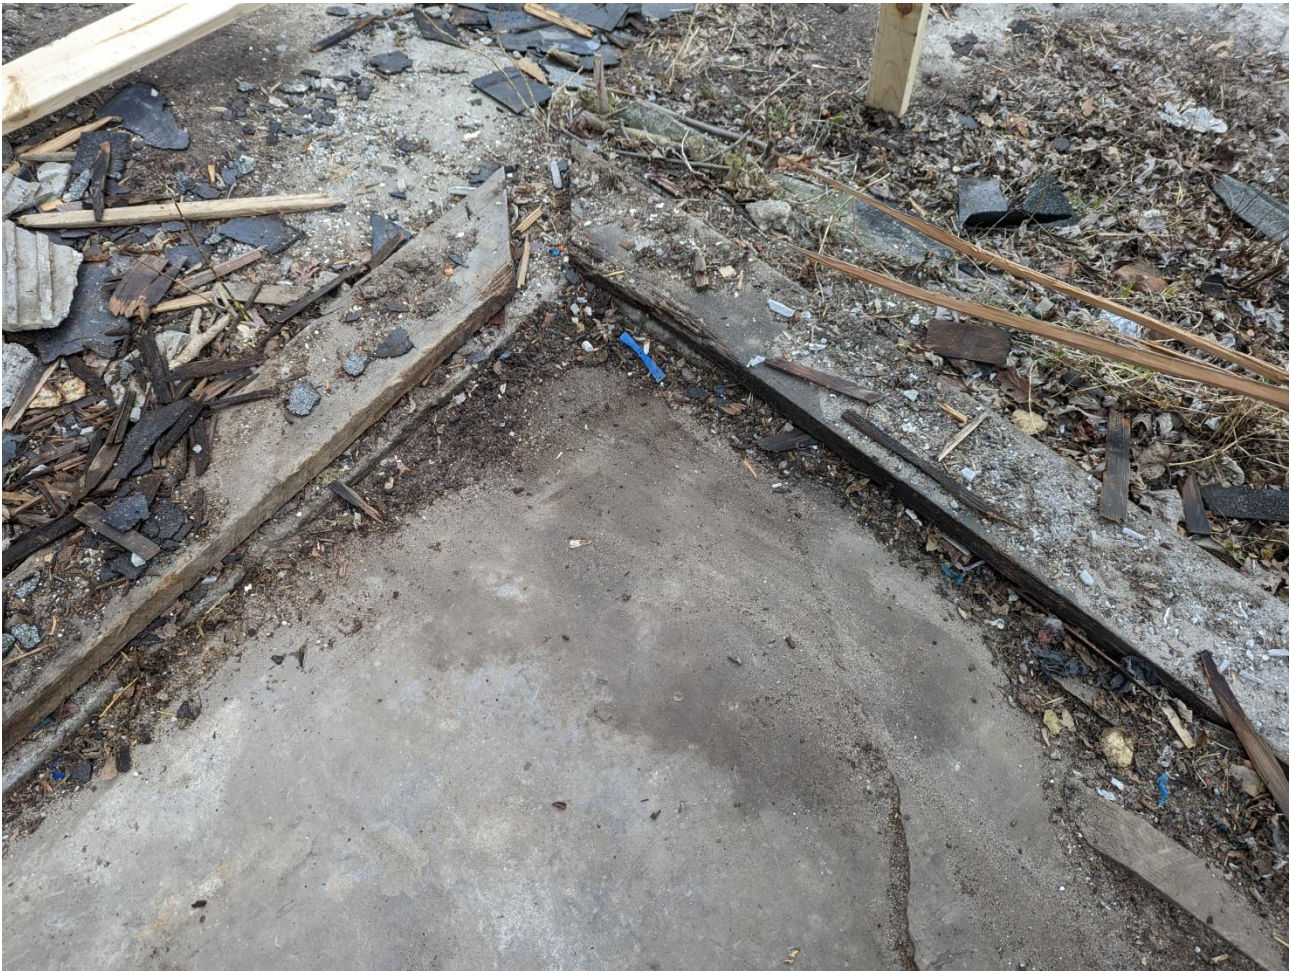
Figure 9 - Concrete slab damaged, needs to be leveled

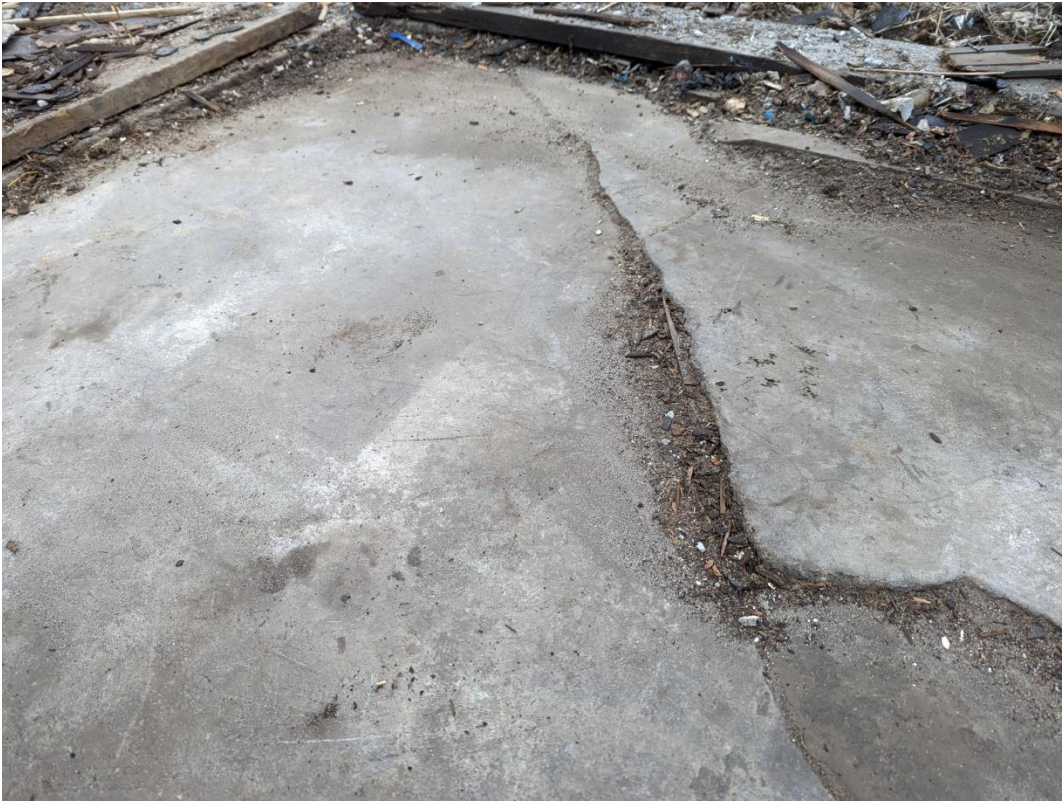
Figure 10 - Post Demolition, uneven concrete slab
