MEMO

Re: Supplemental Photos, Marlboro Apartments, 1031 Marlborough, Detroit, MI

Marlboro Apartments Photo Log
1031 Marlborough, Detroit, MI
February 2019

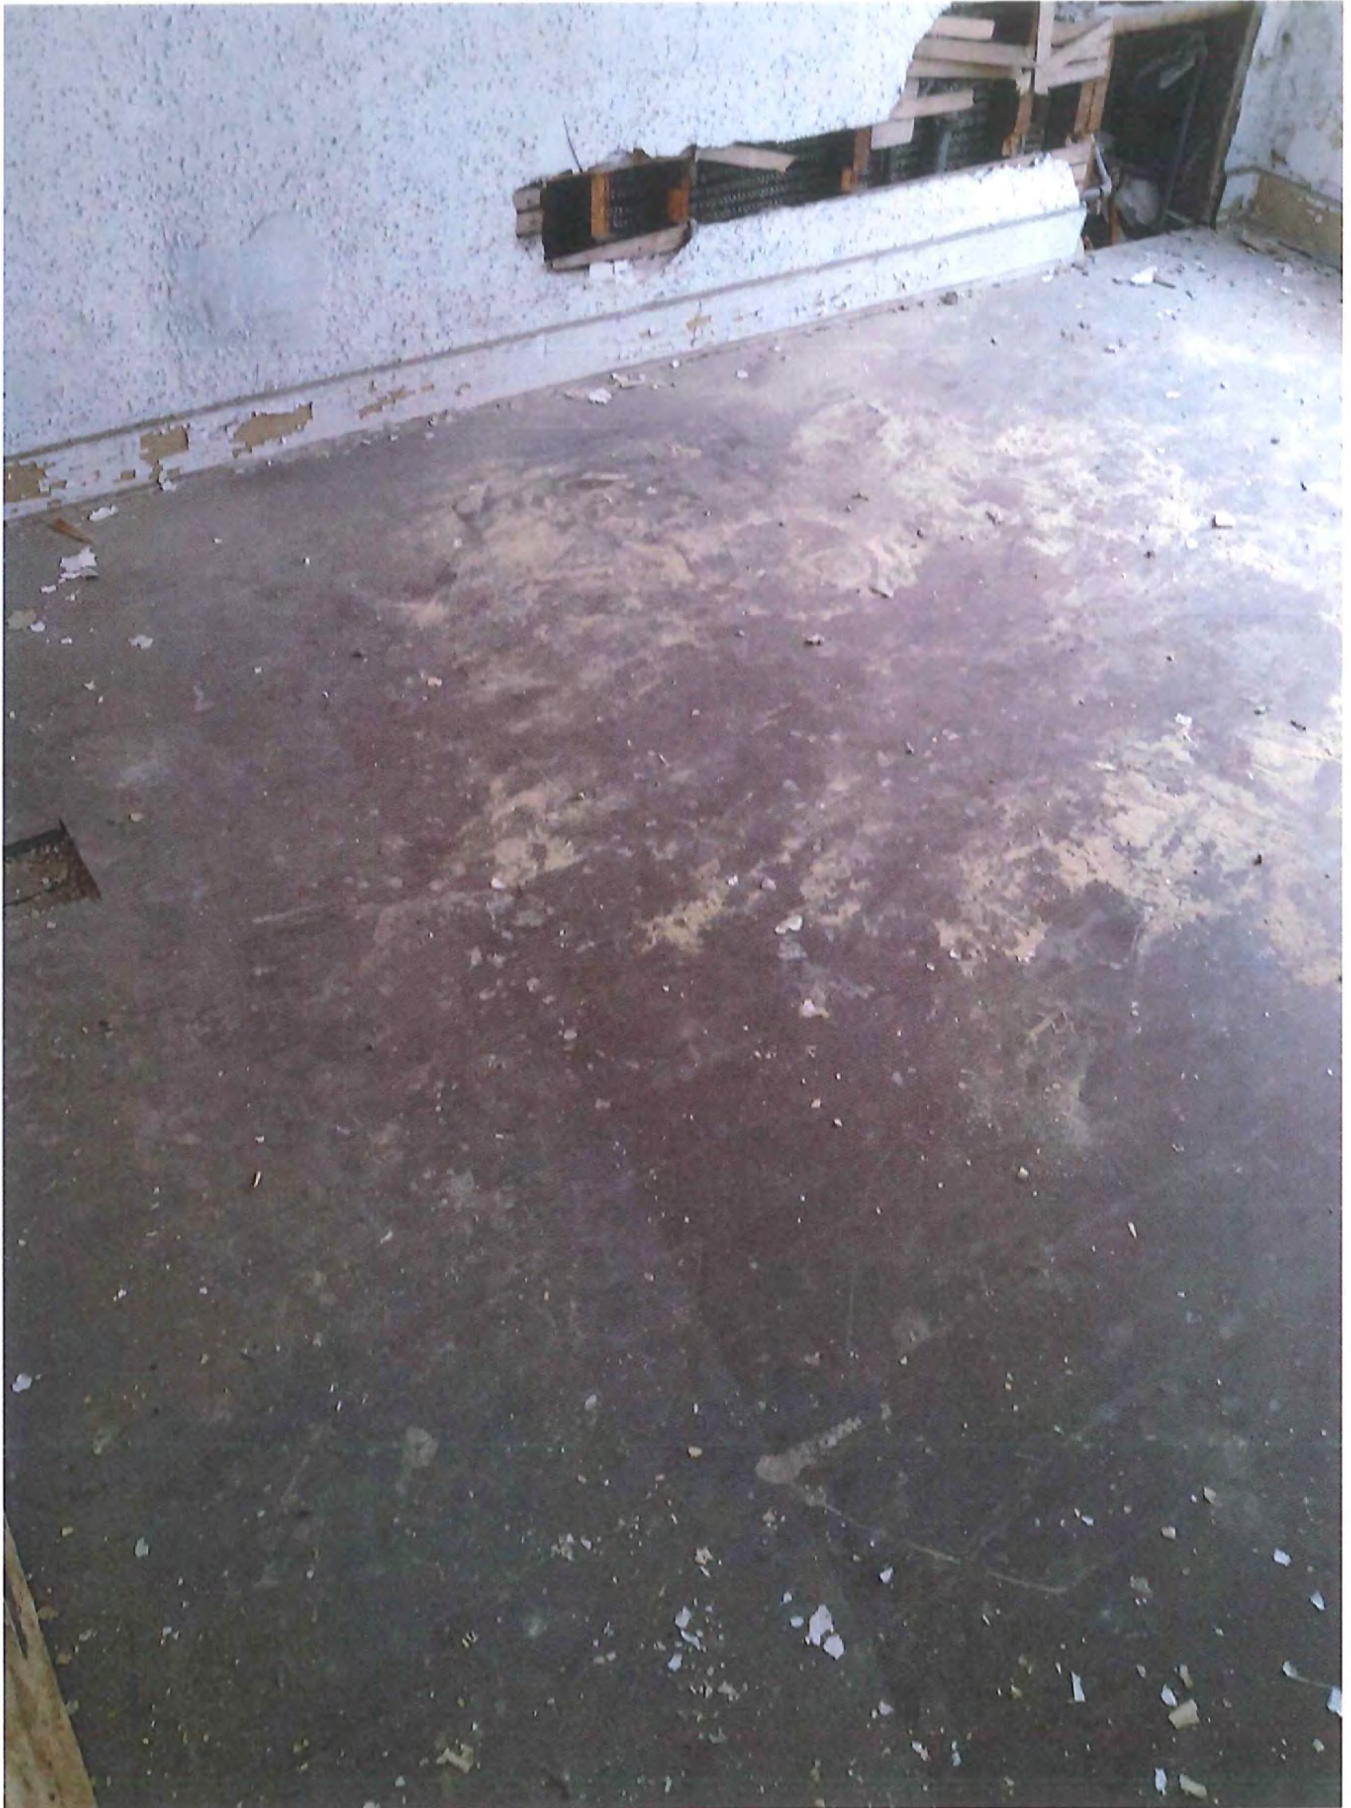
flooring beyond the exposed finish layer into underlayment and framing. In many areas the floor has buckled. Approximately half of the building's flooring is in failing condition or simply missing, leaving gaping holes to the level below. The floors were inspected and evaluated by a flooring contractor, CIC Industries, in early 2019. They have prepared a letter, dated February 18, 2019 summarizing their assessment of the floor conditions in the building. It is their conclusion that the flooring system, including the underlayment, needs to be entirely replaced.

81	KIMG0088	Interior View, Second Floor, Unit 2B, Bathroom, Looking Southwest
82	KIMG0095	Interior View, Second Floor, Unit 2C, Looking West
83	KIMG0098	Interior View, Second Floor, Unit 2C, Floor, Looking Southwest, Typical
84	KIMG0097	Interior View, Second Floor, Unit 2C, Floor, Looking Southeast, Typical
85	KIMG0099	Interior View, Second Floor, Unit 2C, Bathroom, Looking Southwest
86	KIMG0101	Interior View, Second Floor, Unit 2C, Bathroom, Looking Southeast
87	KIMG0118	Interior View, Second Floor, Unit 2D, Plaster Conditions, Looking Northwest, Typical
88	KIMG0117	Interior View, Second Floor, Unit 2D, Floor Conditions, Looking West, Typical
89	KIMG0112	Interior View, Second Floor, Unit 2D, Looking Southwest
90	KIMG0107	Interior View, Second Floor, Unit 2D, Kitchen, Looking Northeast
91	KIMG0108	Interior View, Second Floor, Unit 2D, Kitchen, Looking Southeast
92	KIMG0110	Interior View, Second Floor, Unit 2D, Kitchen, Looking Southeast
