# HISTORIC DISTRICT COMMISSION APPLICATION FOR WORK APPROVAL

HDC2025-00655

### **Existing Analysis Report**

Existing Historic Accessory Structure

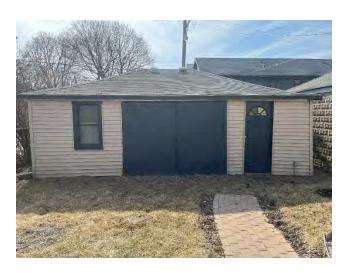
Existing photo - north, rear yard side

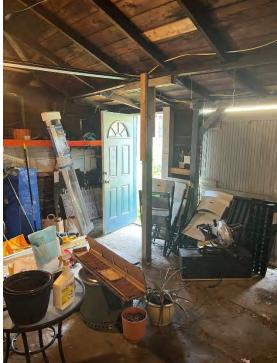
Existing photo – interior

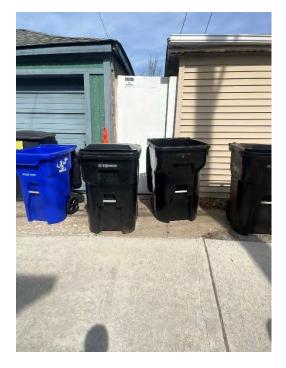
- Sill plates deteriorated and rotting in many locations +/- 50%.
- Anchorage of sill plates to foundation only observed at northeast building corner. Assume consistency at least at corners of building.
- Sill plates up-heaving in northeast corner
- Single top plate inadequate to support rafters and brace exterior wall
- Roof framing members offset from stubs in several instances the offset is 12"
- No evidence of any members or system to prevent shear.
- Extensive structure tilt evident in supporting exterior walls:
  - West wall 8" out of plumb- leaning toward south
  - South wall 4" out of plumb- leaning toward east
  - o East wall 2-1/2" out of plumb- leaning toward south
  - North wall 2-1/2" out of plumb- leaning toward west

Exterior wall out of plumb

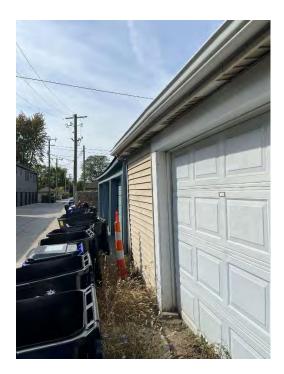
Exterior wall out of plumb

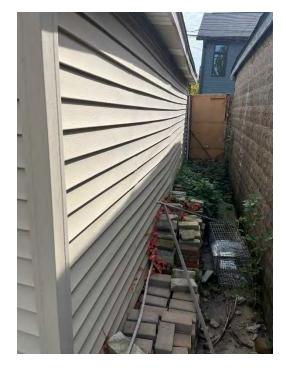
Buckling evident in exterior wall – west side

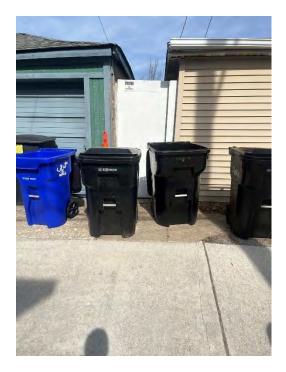
Exterior wall out of plumb

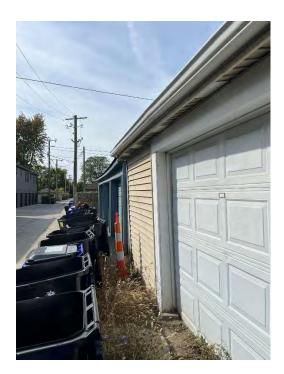
Exterior wall out of plumb

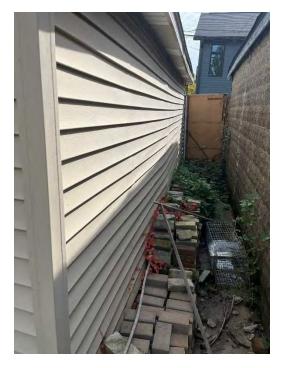
Buckling evident in exterior wall – west side
