# HISTORIC DISTRICT COMMISSION ADDITIONAL INFORMATION REQUEST

**Application Number:** HDC2025-00648

# Inspection Report

**Property Address:**  
19170 Warrington  
Detroit MI 48221

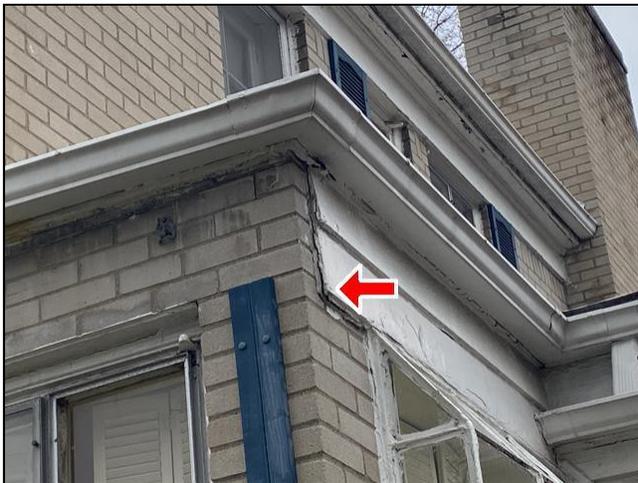
2.2 Item 7(Picture)

(3) Gaps/holes should be sealed against the weather.

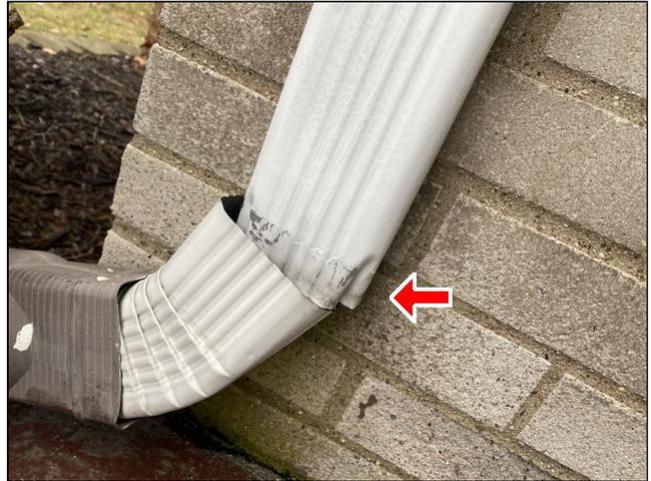
4.5 Item 3(Picture)

(3) We suggest extending downspout drainage well away from the foundation to reduce the chances of water intrusion into the structure.

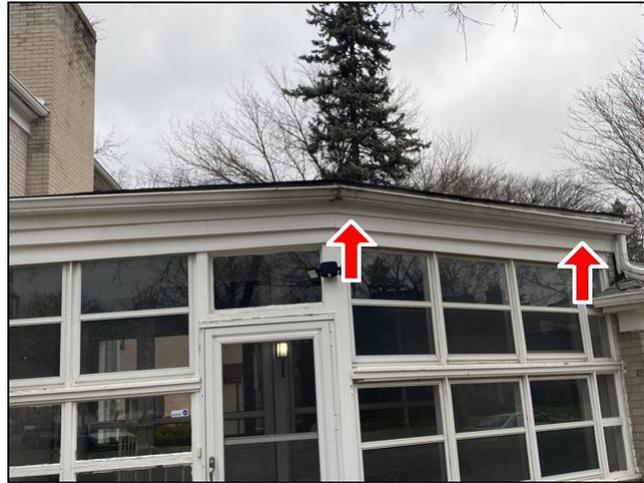
4.5 Item 5(Picture)

(4) Realignment is needed for proper drainage.

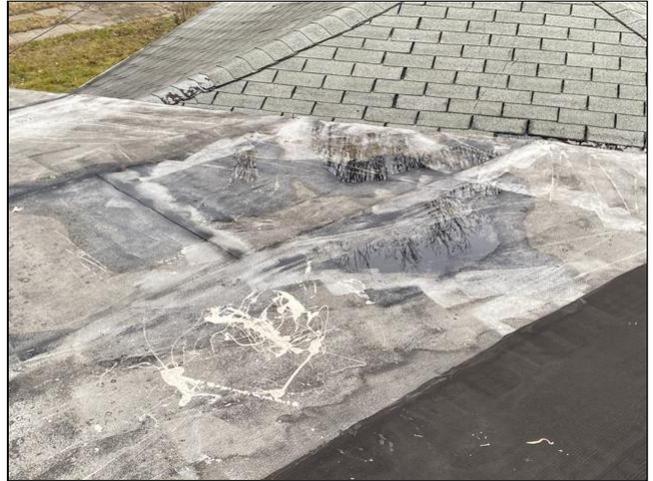
4.6 Item 4(Picture)

(2) Areas appear to have an on-going "ponding" problem. When water remains on a roof longer than 48 hours there is an increased risk of leaks and accelerated roof wear. Steps should be taken to pitch the roof for adequate drainage.

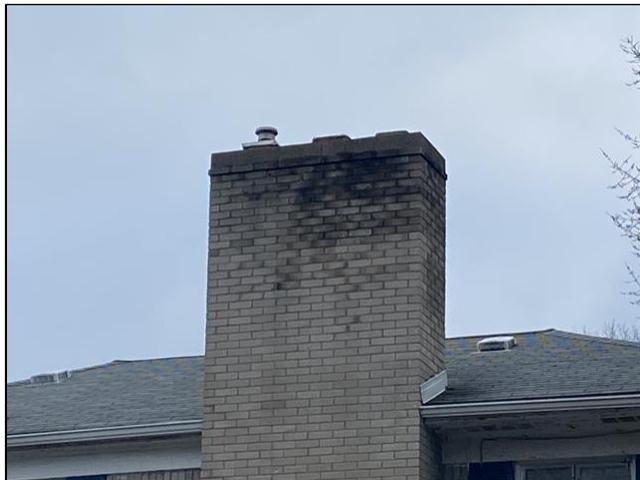
5.1 Item 1(Picture)

(1) The cement chimney cap at the chimney should be sealed as part of routine maintenance. For longer term performance, client may wish to consider upgrading to a full overhanging crown with a sloping top and drip slot at the overhang.

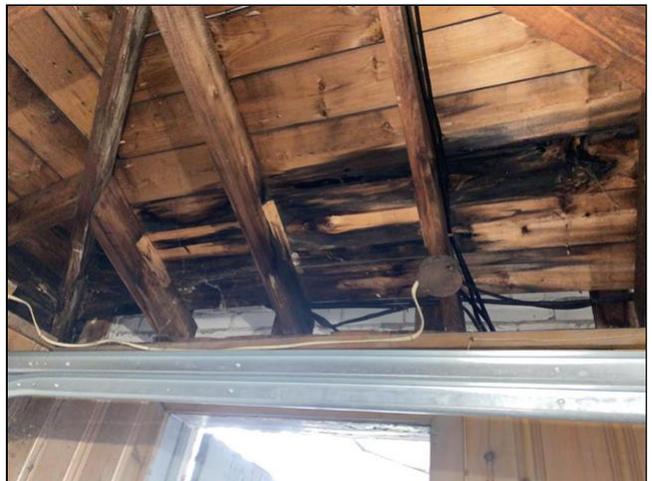
6.1 Item 2(Picture)

The ceiling is deteriorated and reveals a water stain indicating a leak did or still exists. Repairs are needed. A qualified contractor should repair or replace as needed.

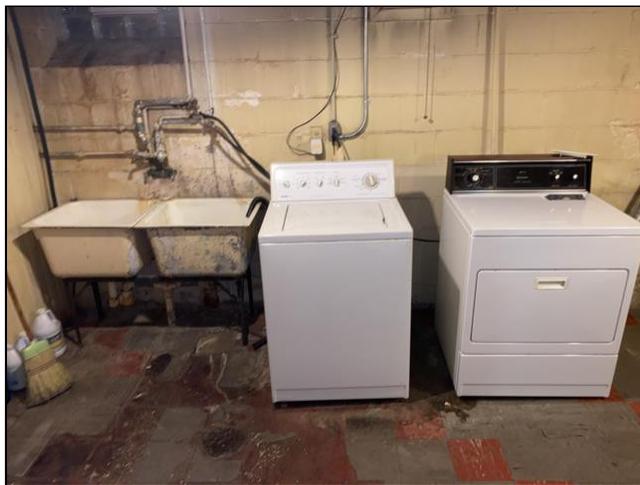
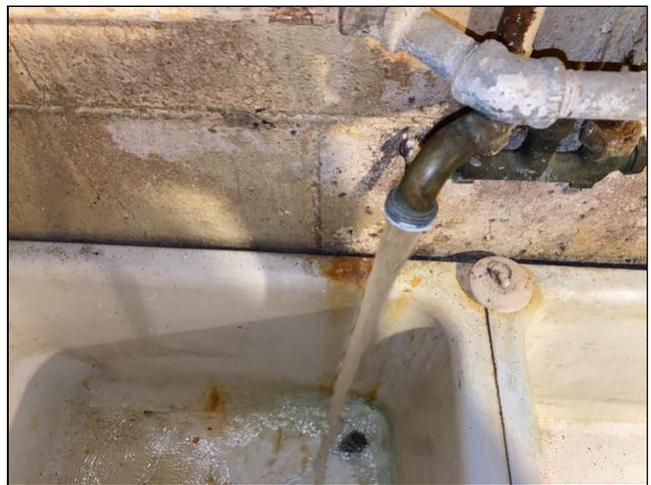
The clothes dryer vent is kinked/ restricted. Clothes dryer vents that are not vented properly can cause moisture/lint problems and could be a fire hazard. A qualified contractor should repair or replace as needed.

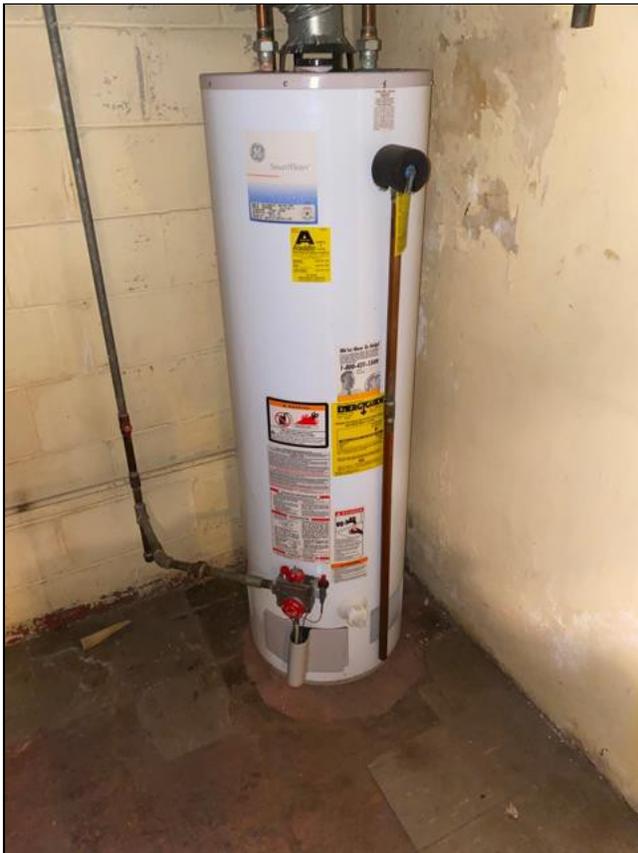
Water Heater ok

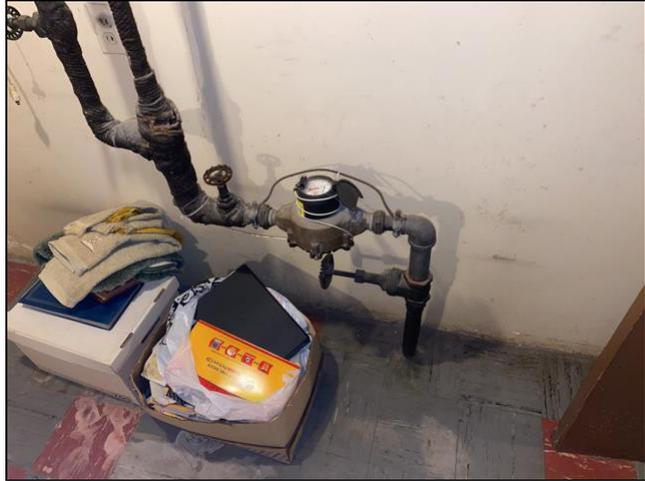
12.3 Item 1(Picture)

An electrical bonding jumper is present at the meter as desired and no leaks or corrosion are visible.

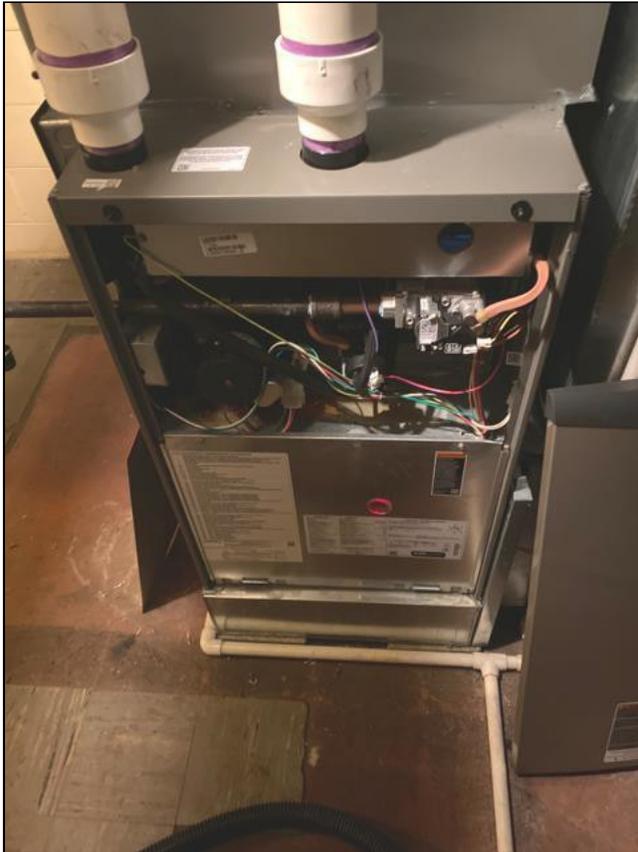
Furnace ok

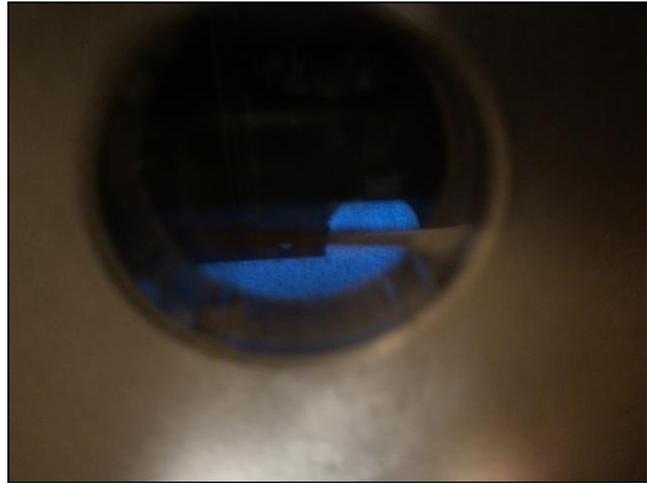
13.3 Item 1(Picture)

Combustion chamber ok

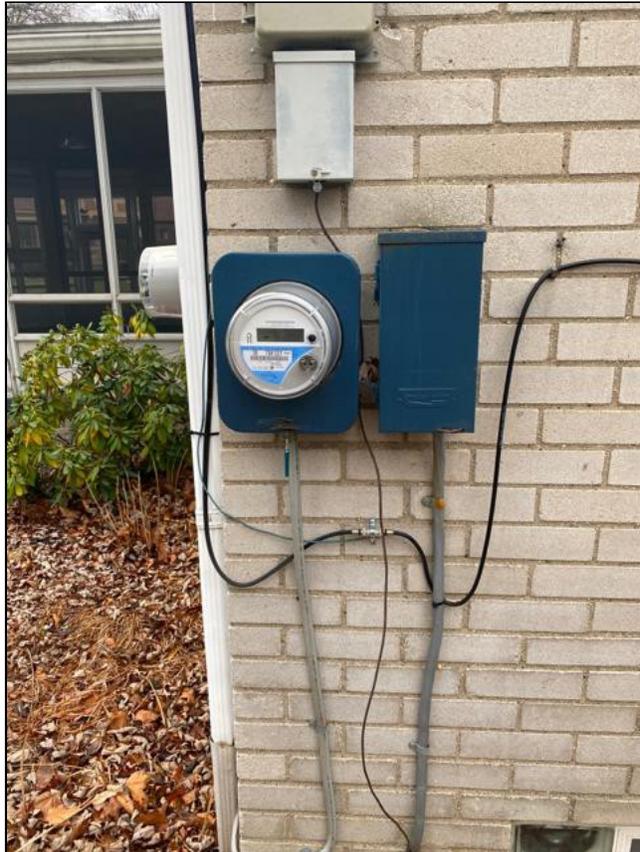
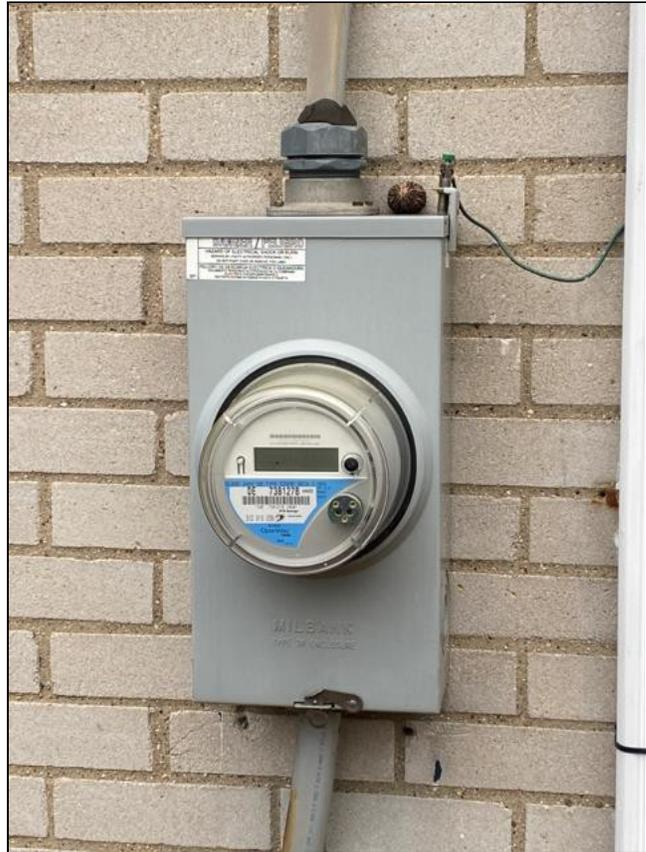
Service entry ok

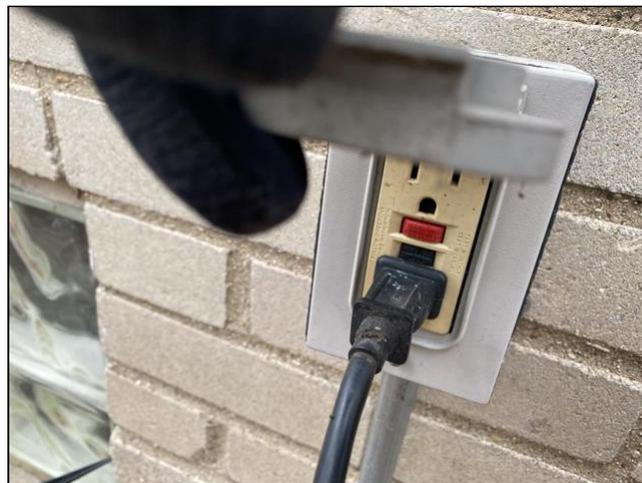
14.2 Item 1(Picture)

Exterior outlet won't reset.

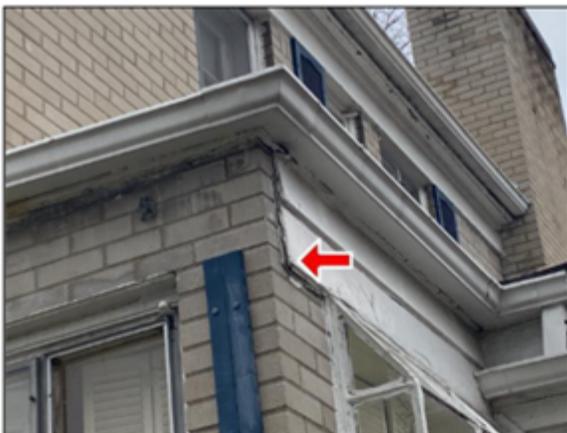
2.2 Item 7(Picture)

(3) Gaps/holes should be sealed against the weather.
