HISTORIC DISTRICT COMMISSION APPLICATION FOR WORK APPROVAL

APPLICATION ID
HDC2026-00195

ADDRESS(ES): 1000 St Anne Street
HISTORIC DISTRICT: Ste. Anne's Parish Complex

Subject: HDC Application for Ste. Anne de Detroit: Exterior Restoration - Request for COA revision, Historic Wood Windows, Replacement Windows, and Basement Masonry Openings

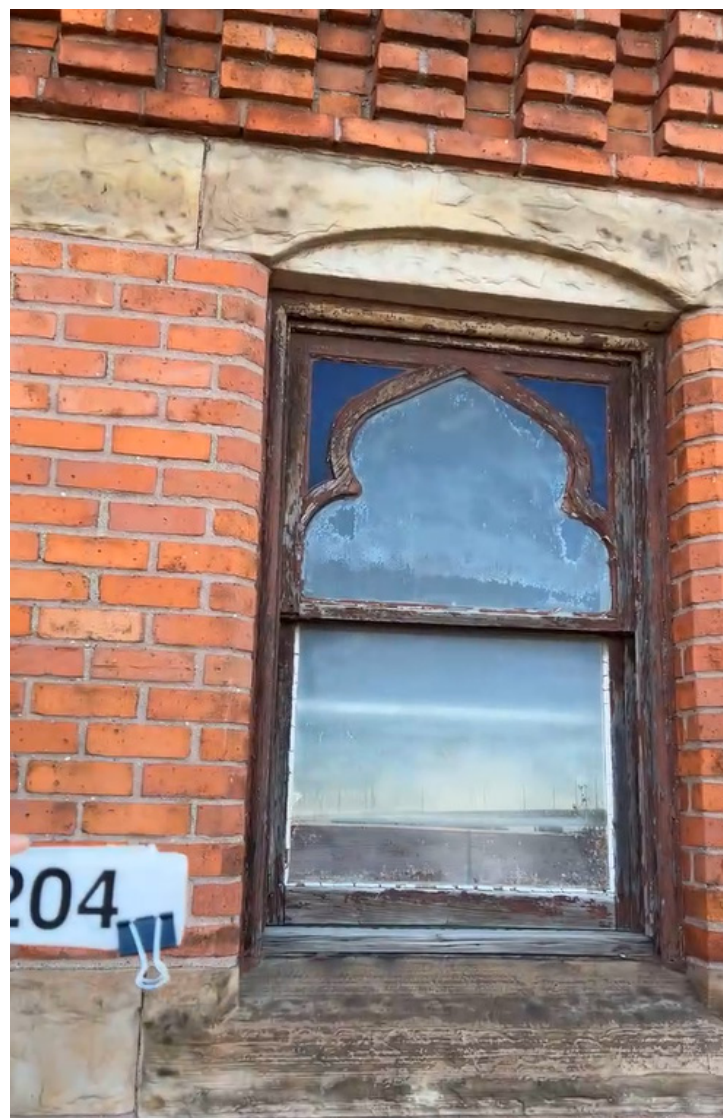
View of existing historic wood window #204 at Basilica (sacristy), 2nd floor, west elevation.

Three historic wood double-hung windows (#203, #204, and #205) at 2nd floor, west elevation. Custom in-kind wood windows proposed for replacement.

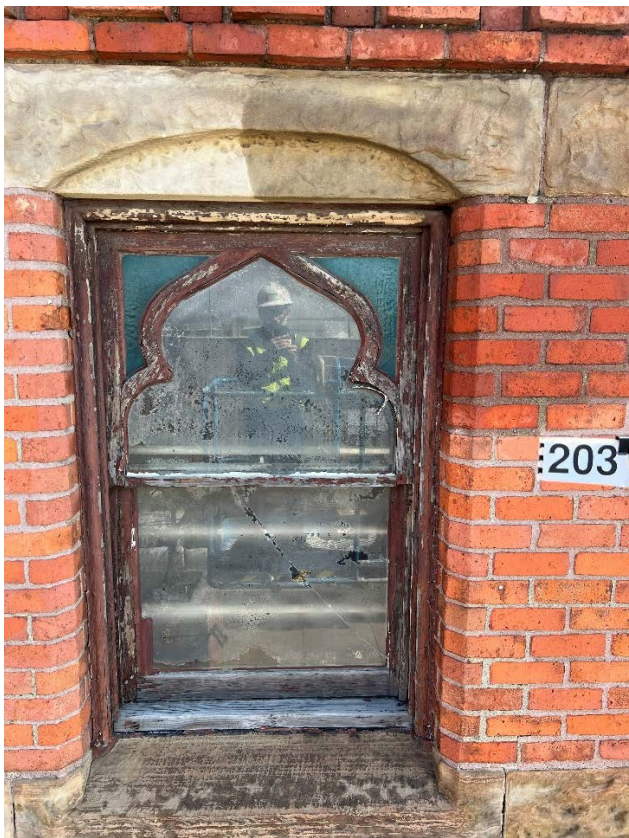
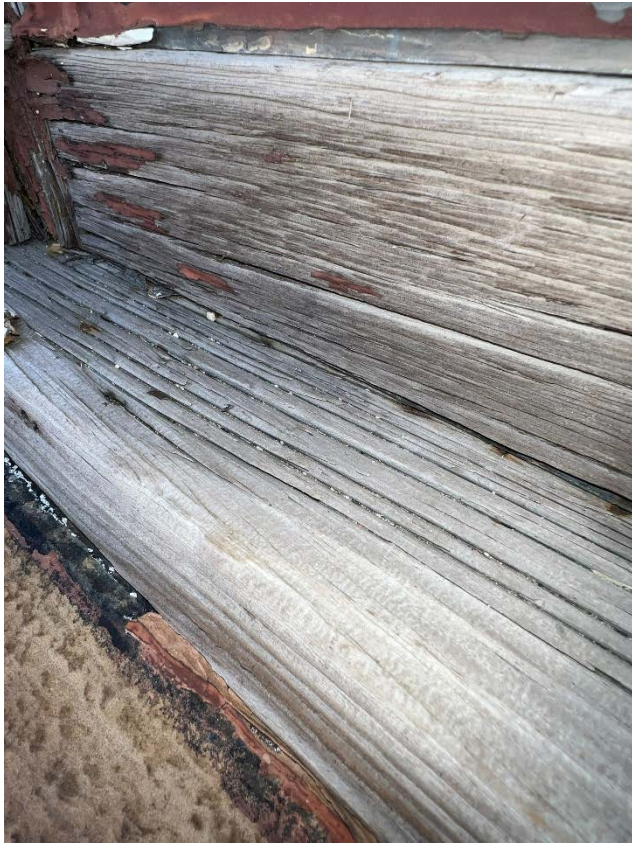
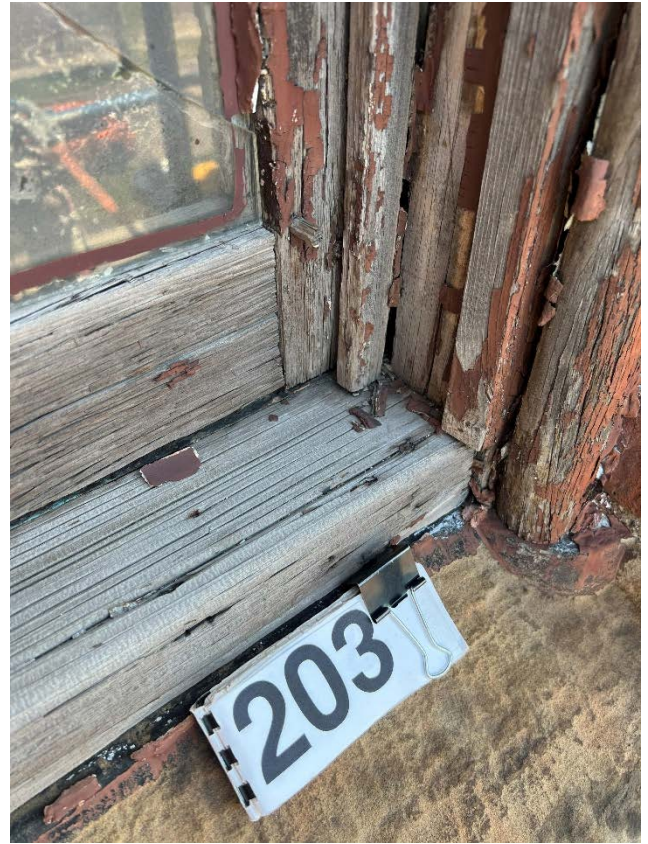
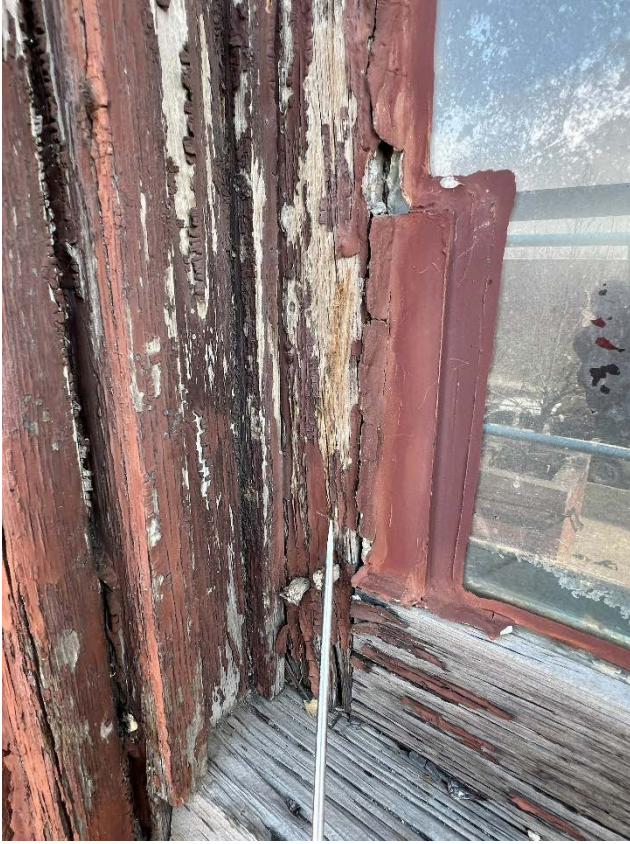
WINDOW #203 exterior elevation and detail views:

HDC App. for Ext. Restoration: Addl. photos of exist. window conditions at windows proposed for replacement

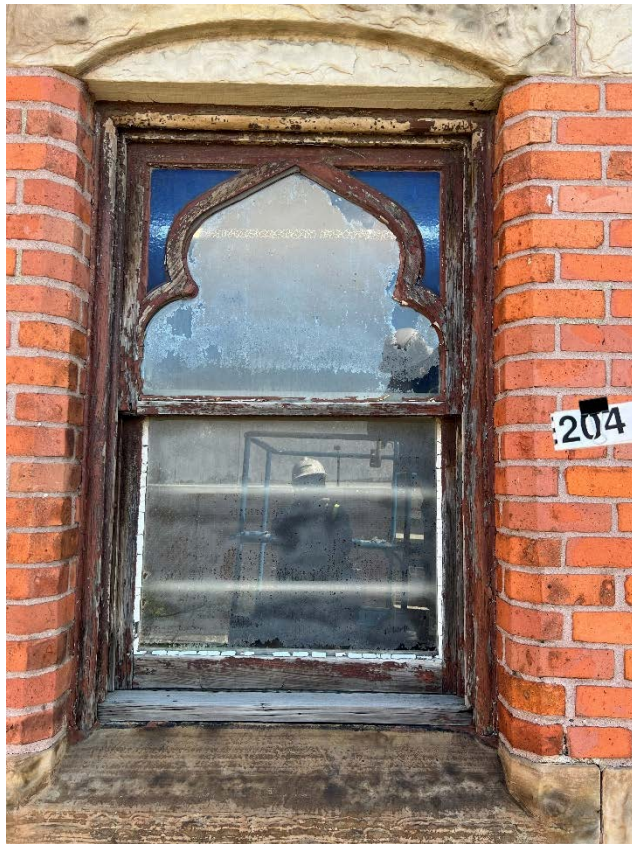
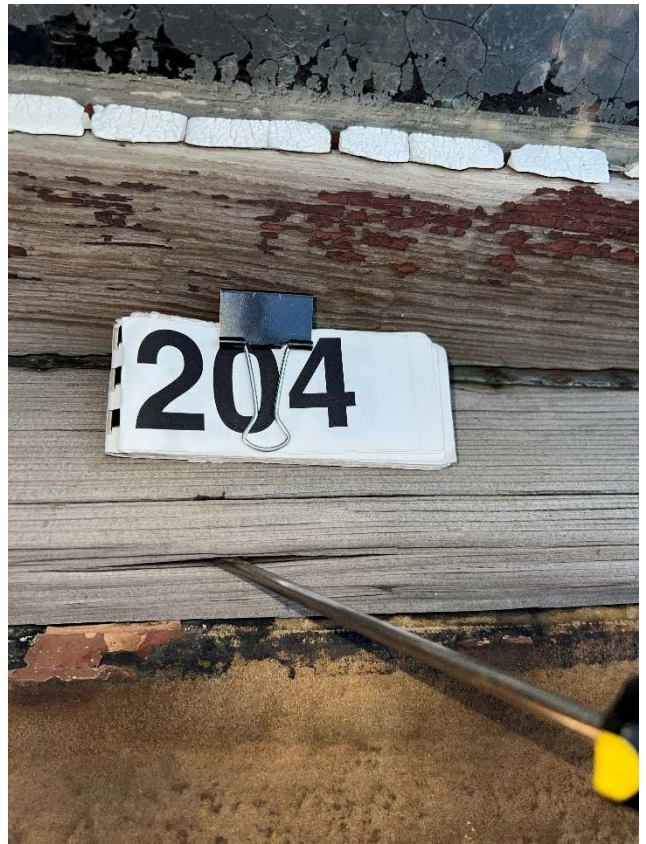
WINDOW #204 exterior elevation and detail views:

HDC App. for Ext. Restoration: Addl. photos of exist. window conditions at windows proposed for replacement

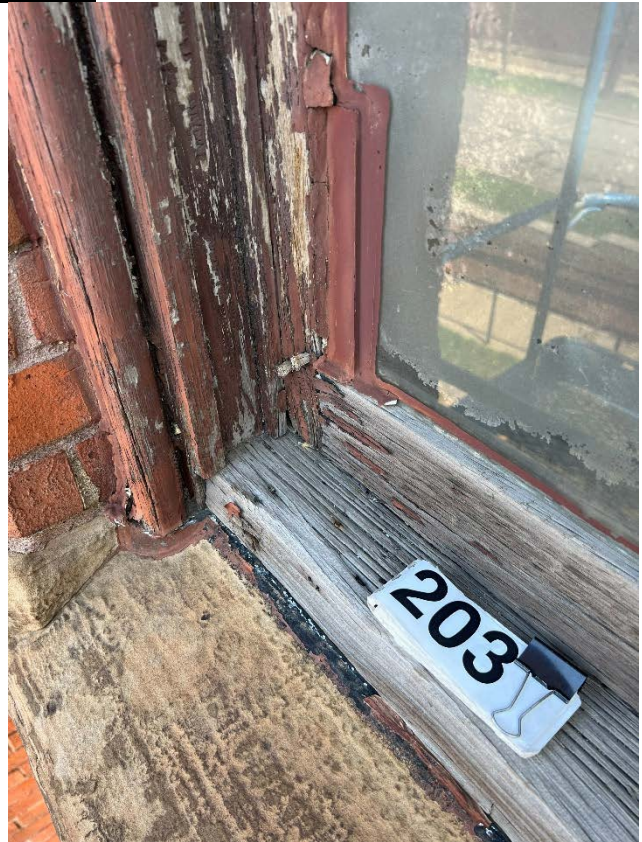
WINDOW #203 exterior elevation and detail views:

Three historic wood double-hung windows (#203, #204, and #205) at 2nd floor, west elevation. Custom in-kind wood windows proposed for replacement.

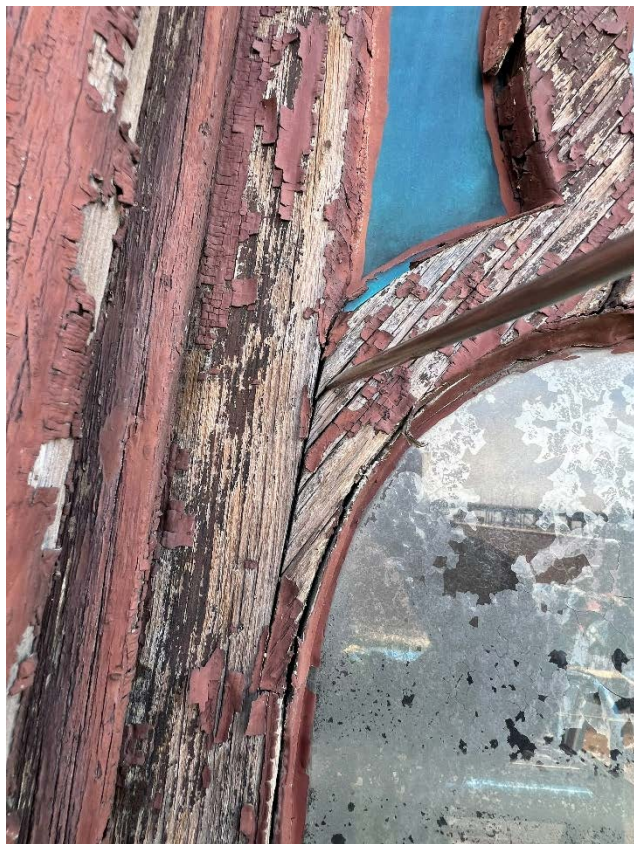
HDC App. for Ext. Restoration: Addl. photos of exist. window conditions at windows proposed for replacement

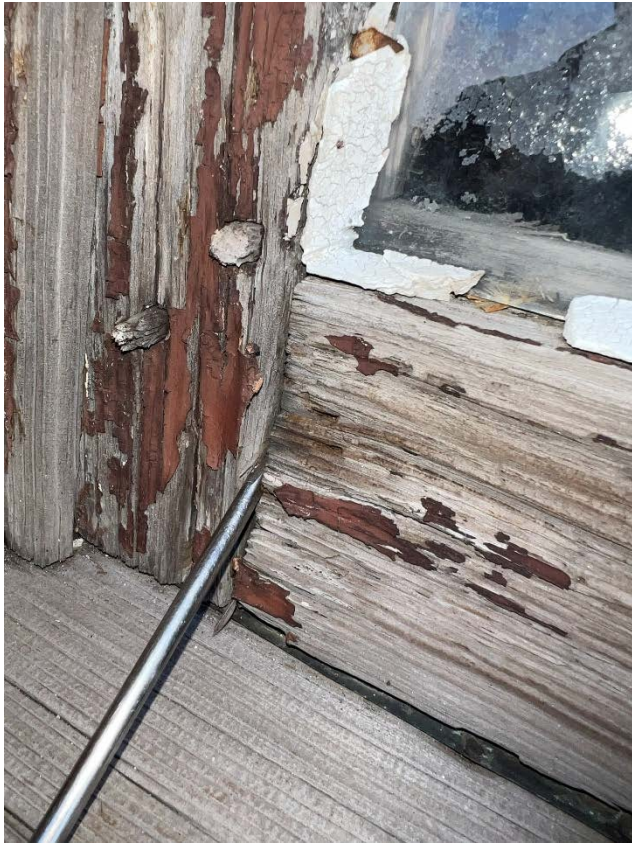
HDC App. for Ext. Restoration: Addl. photos of exist. window conditions at windows proposed for replacement

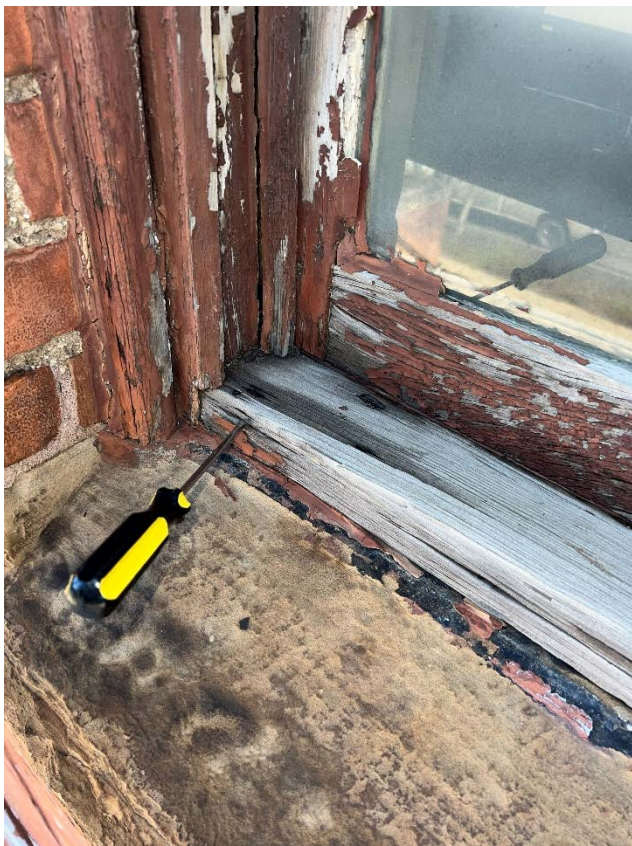
HDC App. for Ext. Restoration: Addl. photos of exist. window conditions at windows proposed for replacement

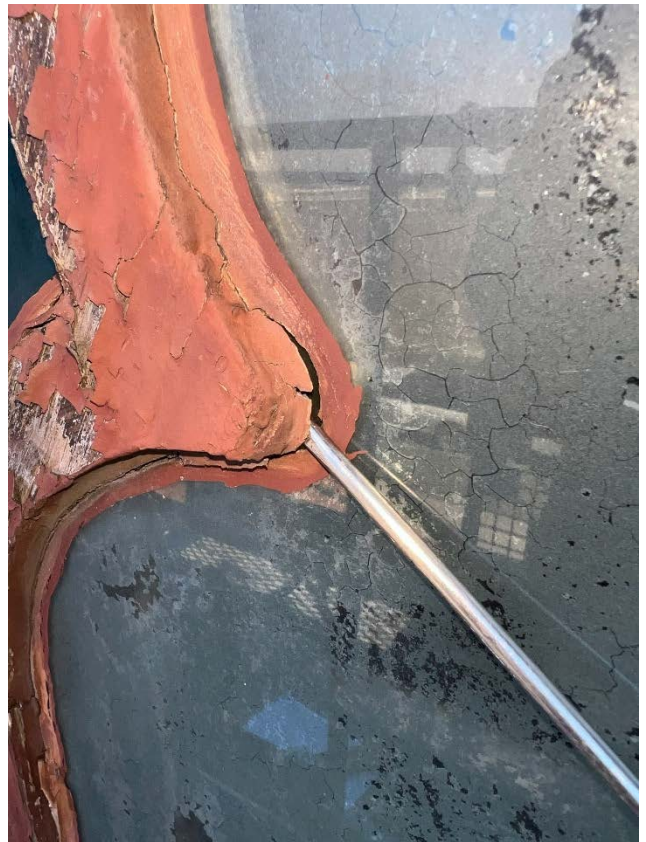
HDC App. for Ext. Restoration: Addl. photos of exist. window conditions at windows proposed for replacement
